# Shaft Eccentricity and Bearing Forces

**Central Maintenance Department  
(Vibration Section)  
EQUATE PETROCHEMICAL COMPANY  
KUWAIT**

## Case

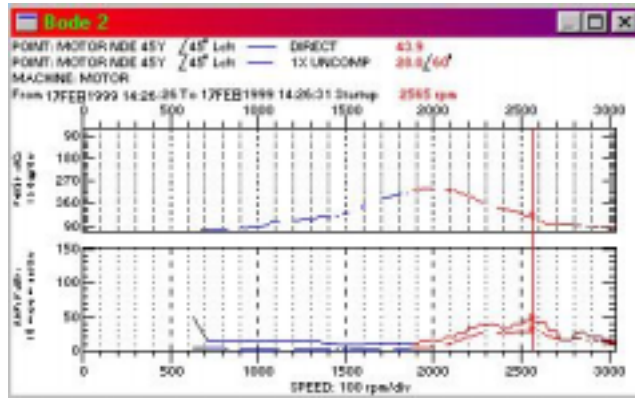
**Fig 2. Bode plot of Motor outboard Y-probe**

The Machine started off normally and the vibration amplitudes during the critical speed and at the running speed remained within the limit. The maximum vibration level observed at the Motor outboard was 1.85mils(47microns), at the critical speed. The vibration level at the rated speed, immediately after start-up, settled down to 35microns, which was high as compared to the normal start-ups.

The Bode plot shows split resonance on both the bearings. No sub synchronous and non-synchronous components were detected.

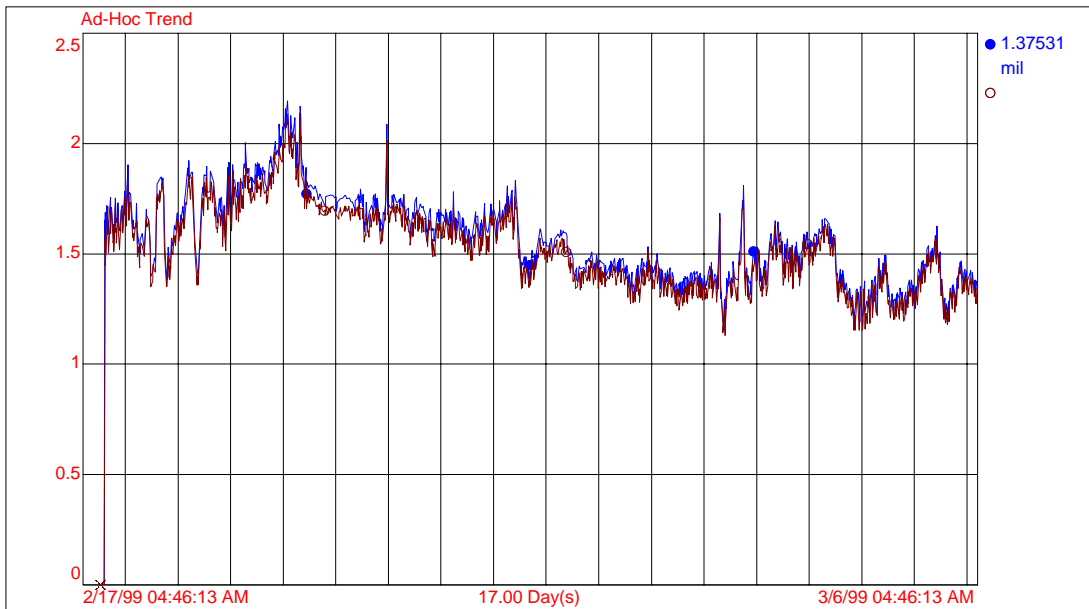
**Fig 3. Trend plot of the Motor Outboard Vibration**

The Fluctuation of vibration level at the Motor Outboard was gradual and initially the vibration amplitudes increased more than 2mils and started reducing, but the fluctuation persisted. The loading cycle of this compressor is normally 4 to 6 hours.

Fig.3 and Fig.4 show the trend data of the Vibration and bearing temperature at Motor Outboard. The normal Vibration level on this machine is less than 0.7mils-.The Overall Vibration level as well as the bearing temperature is observed more than the normal levels. The Vibration level during the loading went to a maximum of 2.2mils and started falling off, once the load was stabilized.

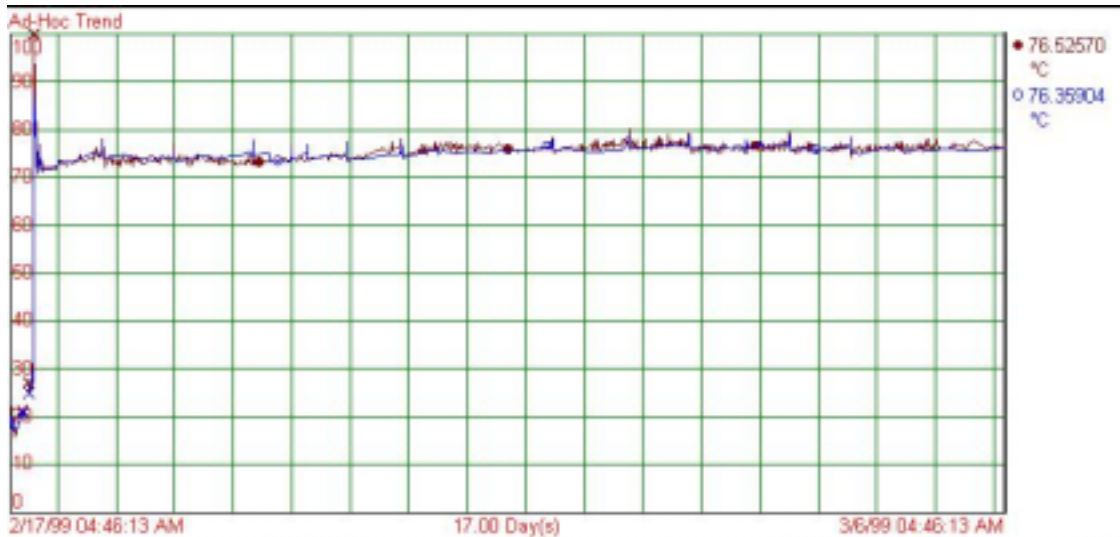
**Fig 4. Trend plot of the Motor Outboard Bearing Temperature**

The vibration level continued to show fluctuation and the bearing temperature remained at around 76 deg with no increasing trend. As the levels, were less than the alarm setpoints, the machine was allowed to operate till the next emergency shutdown was scheduled. The Vibration levels and the bearing temperature were kept under close monitoring.

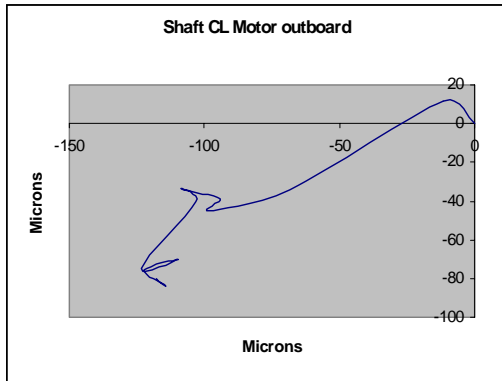
**Fig 7. CL including start-up**

The data from the ADRE was imported to excel sheet, to generate a trend plot of the shaft position, at the same timestamps as that of the above process and phase data. **The plot at Motor outboard showed abnormal variation in the shaft attitude angle. The shaft movement is shown in the fig 7.**

Fig 8 shows the shaft CL plot at Motor Inboard, where the shaft position is normal compared to the Motor Outboard-Fig 7. The plots of the Compressor bearings were also normal. As the source of the abnormal behavior was obviously pointing towards the outboard bearing, it was decided to open and inspect the Motor Outboard assembly.

The Tilted pad bearings are inherently stable due to the low cross-coupled bearing stiffness forces, which results in normally small attitude angles. **The “locked” bottom left shoe has thus modified the hydrodynamic forces in the bearing, introducing the cross-coupled stiffness coefficients.** This has resulted in the varying bearing forces in the bearing. The excessive drift towards the bottom left quadrant of the bearing may be attributed to the reduced load carrying capacity of that “locked” shoe.

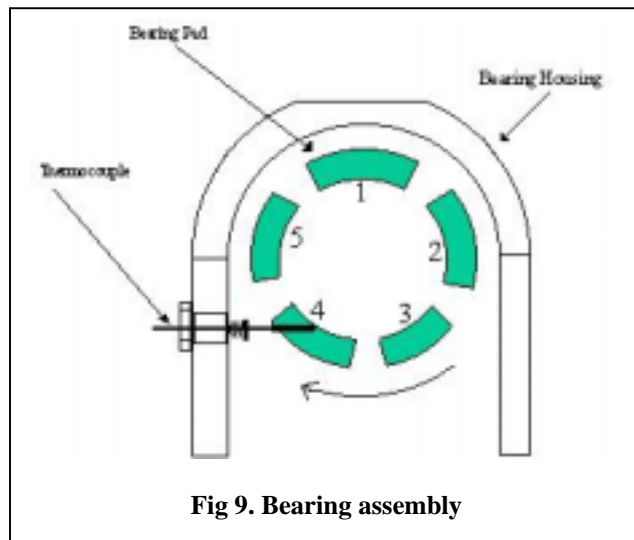
**Fig 9. Bearing assembly**

As shown in the figure, **the bottom left pad at its trailing portion has got a small hole on the backside, for accommodating bearing thermocouple.** All the shoes were identical, except the Bottom left shoe labeled #4. This shoe, therefore, should be positioned with the hole aligned to the thermocouple, as depicted in the figure.

**The bearing assembly was inspected and it was observed that the Bottom left pad was inadvertently placed upside down, with the hole at the leading portion.** So the

thermocouple, during installation, not being aligned with the hole, had pre-loaded the shoe excessively, preventing it from functioning.

The shoes were put back in the right position and the machine was put on line on 30/4/99.

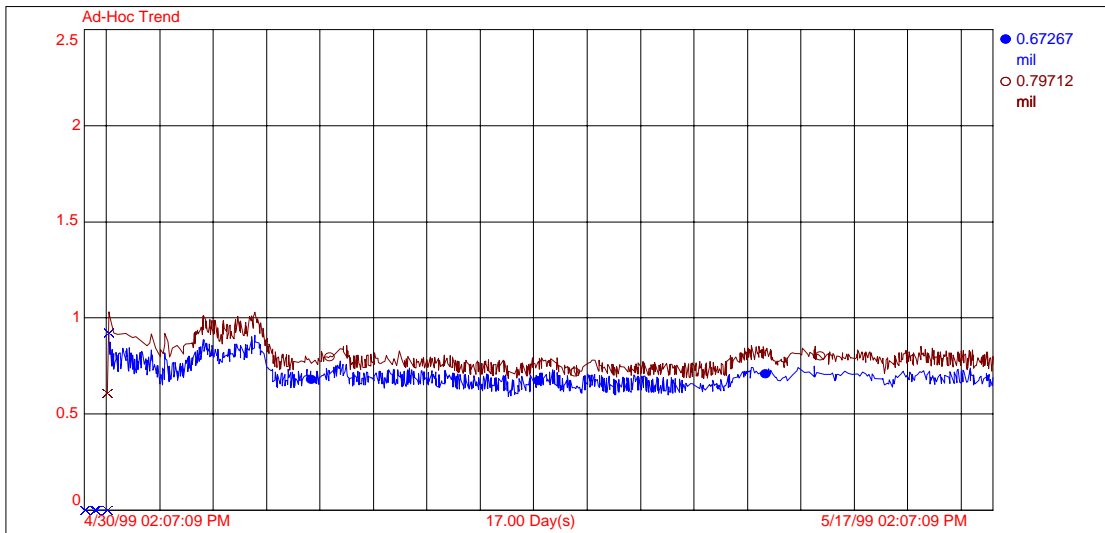
**Fig 10. Vibration trend during final run**

Fig.10 and Fig.11 shows the final vibration and the bearing temperature trend levels. The Vibration levels resumed to normal and the fluctuation also vanished. The Bearing temperature reduced from the 76deg to normal 67 deg.
